UNDERWATER BRIDGE INSPECTION REPORT

STRUCTURE NO. L8228

SOUTH BRANCH OF THE BUFFALO RIVER

DISTRICT 4 - CLAY COUNTY

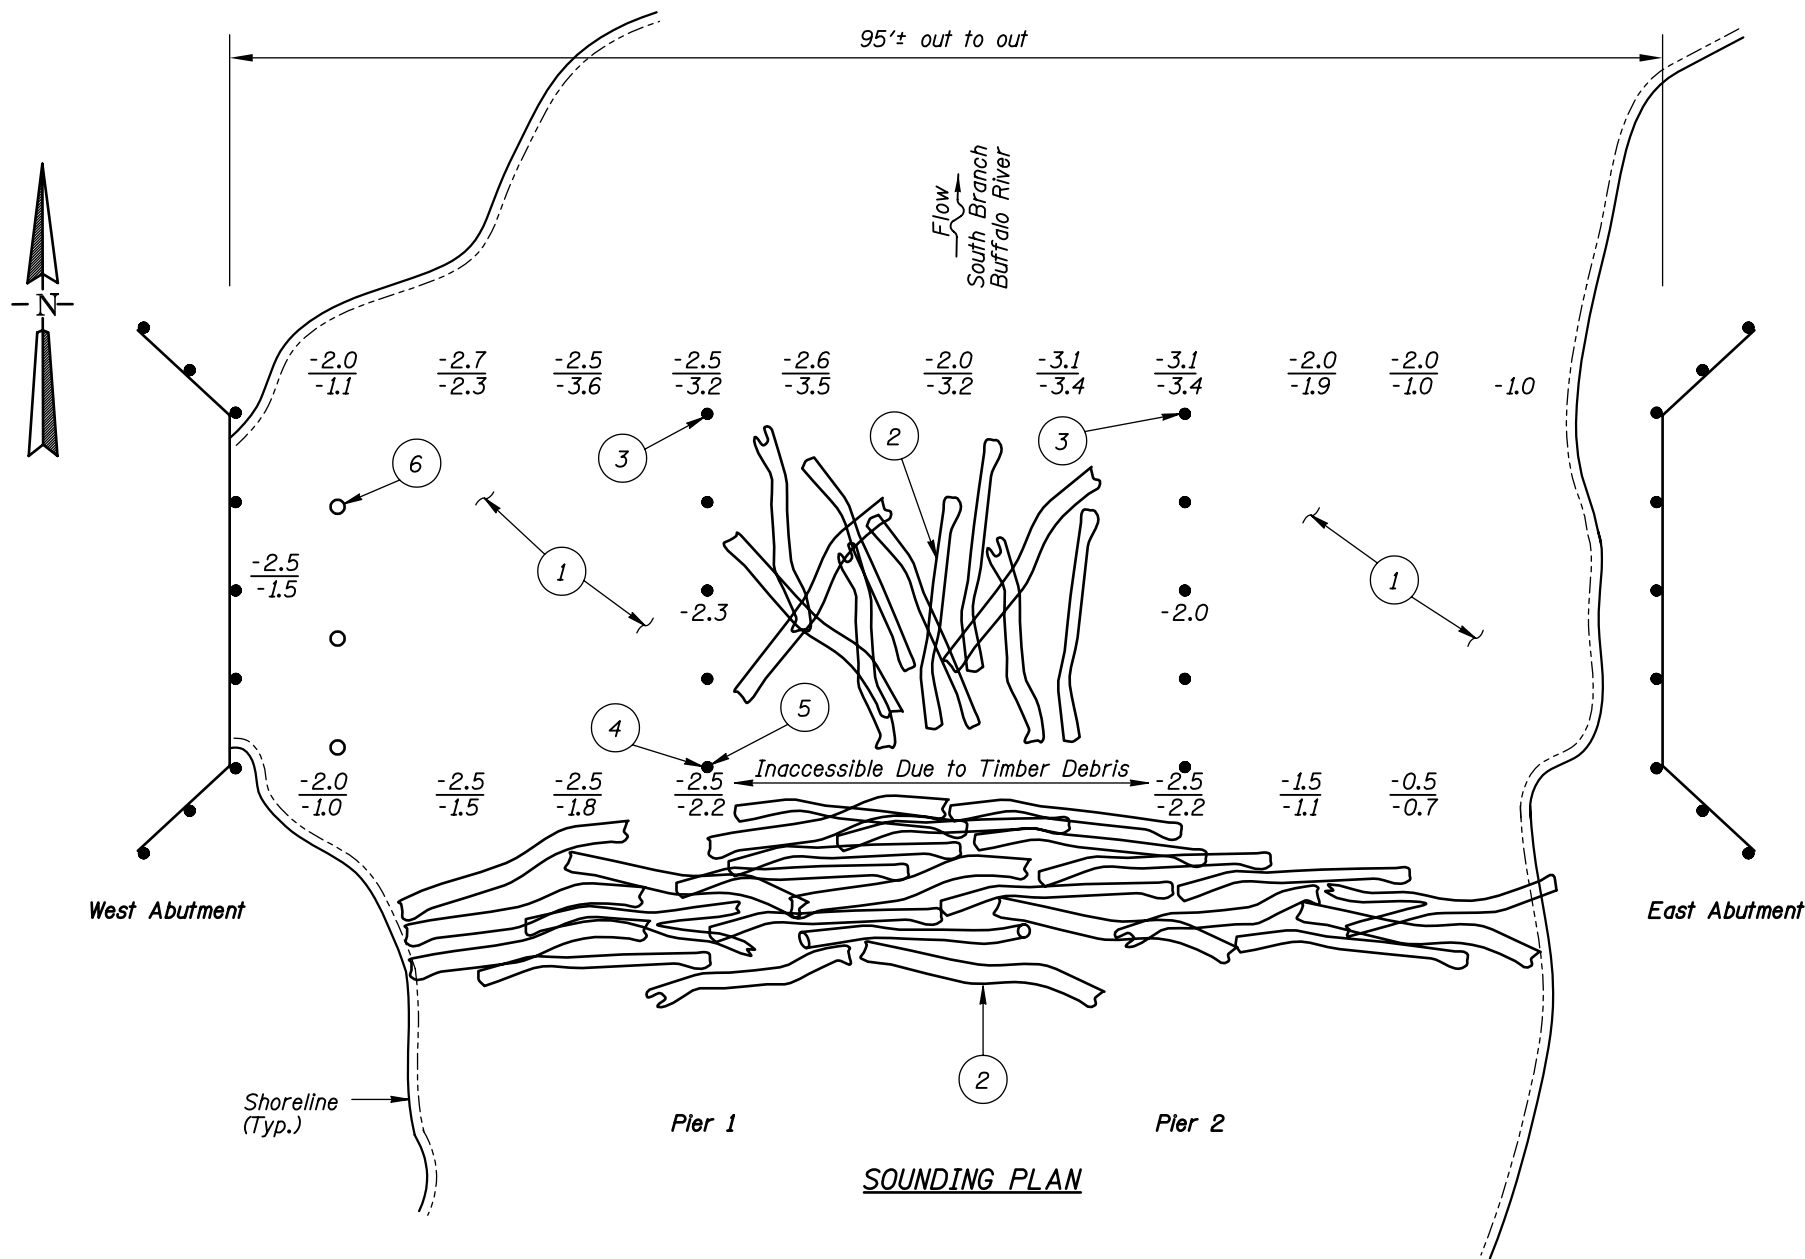
INSPECTION AND SOUNDING PLAN

- 1 The channel bottom consisted of matted small branches and twigs and silt with up to 1 foot of probe rod penetration.
- 2 Very heavy accumulations of timber debris were observed across the entire channel width from the upstream fascia and extended 50 to 100 feet upstream of the bridge. Timber debris also continued through the the center span and extended to the downstream fascia. The timber debris consisted of branches and trees up to 3 feet in diameter.
- 3 The diagonal bracing was split at the connection below the waterline, measuring 2 inches wide by 8 feet long maximum.
- 4 The diagonal bracing was split at the pile cap connection, measuring 1 inch wide by 4 feet long.
- 5 The diagonal bracing was weathered and decayed for a length of 6 feet and exhibited 40 percent section loss.
- 6 Old cut off piles were observed protruding from the channel bottom. (Typical)

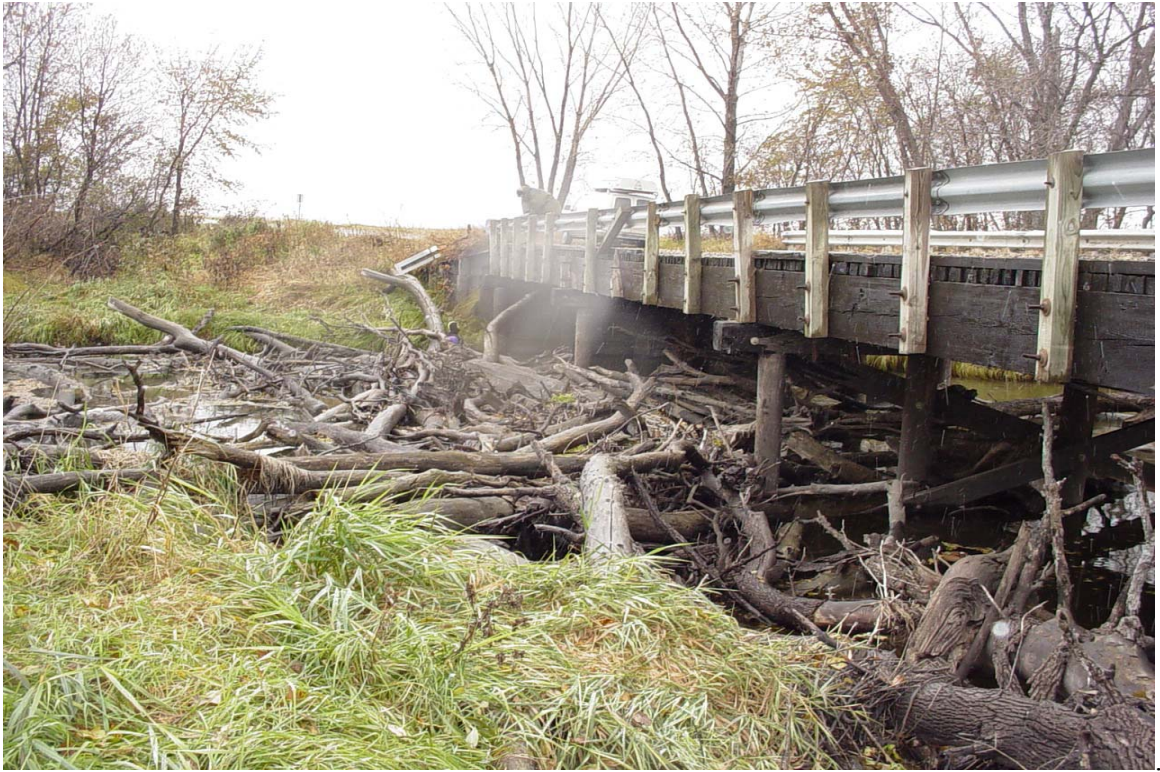
- (A) The diagonal timber braces were split through the connections at several locations at both piers. The splitting in the connections measured up to 2 inches wide by 8 feet in length. A diagonal brace at the south end of Pier 1 exhibited weathering and decay with a 40 percent loss of section.
- (B) A very heavy timber debris accumulation was observed across the entire channel width at the upstream (south) fascia of the bridge. The timber debris extended 50 to 100 feet upstream, continued through the center span, and extended to the downstream fascia. The debris consisted primarily of branches and trees up to 3 feet in diameter. The amount of debris and the potential for excessive lateral loads during high water and flow conditions is considerable.

Photograph 1. Overall View of the Structure, Looking Northwest. Note Heavy Timber Debris Accumulation.

- (A) Remove the heavy accumulation of timber debris from around structure to eliminate the potential for continued accumulation, scour influence, and excessive lateral loads on bridge.
- (B) Repair/replace the split and decayed timber braces to restore lateral stability to the piers.
